***Reliability Services & Vibration Analysis
Report
JULY 2010***

Manufacturing & Mining Incorporated

July 23, 2011

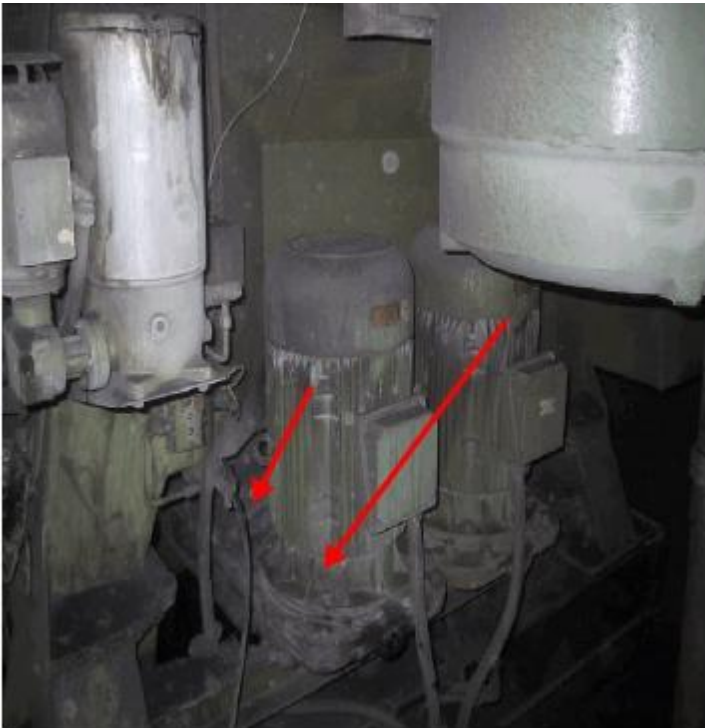
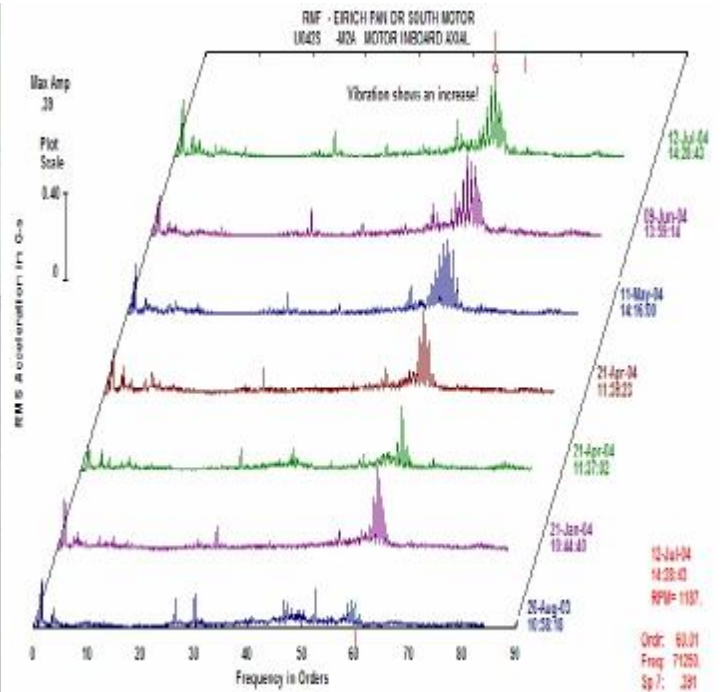
Area Main Floor
Equipment U042S EIRICH PAN DR SOUTH MOTOR

Area	Main Floor		
<u>Urgency</u>	<u>Equipment</u>	<u>Problem</u>	<u>Extended Description</u>
Priority 2	U042S EIRICH PAN DR SOUTH MOTOR	12-Jul-04 - Gear defects - Gear, Simple	Pan drive motor and gearbox show an increase of gear defects/bearing defects and looseness. Monitor closely, unit should be repaired/replaced at soonest opportunity.
Priority 3	EMRAM East Melt Rapid Air Make up	12-Jul-04 - Antifriction bearing defect - Air Handler (Fan),	Increase in vibration indicates early bearing defects. Monitor this condition. Inspect and schedule repairsLubricate frequently.
Priority 3	U082WN #2 BMD BLAST NORTH SHOT WHL	12-Jul-04 - Imbalance - Bearing Component	Overall vibration level increasing. Balance rotating assembly.
Priority 3	EDVPE East Disa Vac Pump East	12-Jul-04 - Antifriction bearing roller defects - Motor, AC	Motor bearing shows an increase in bearing defects and looseness. Monitor closely, lubricate frequently.

Title: 12-Jul-04 - Gear defects - Gear, Simple

Explanation: Pan drive motor and gearbox show an increase of gear defects/bearing defects and looseness. Monitor closely, unit should be repaired/replaced at soonest opportunity.

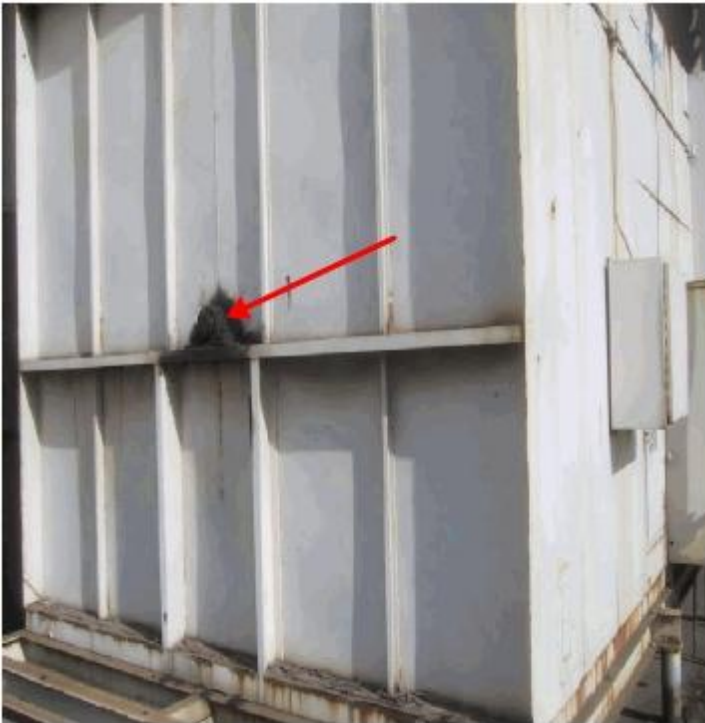
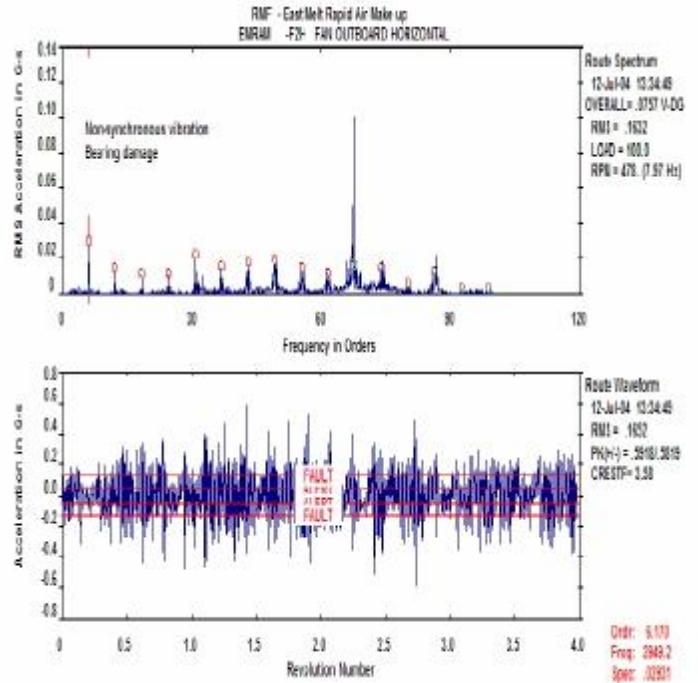
Area Main Floor
Equipment EMRAM East Melt Rapid Air Make up

Title: 12-Jul-04 - Antifriction bearing defect - Air Handler (Fan), Centrifugal

Explanation: Increase in vibration indicates early bearing defects. Monitor this condition. Inspect and schedule repairsLubricate frequently.

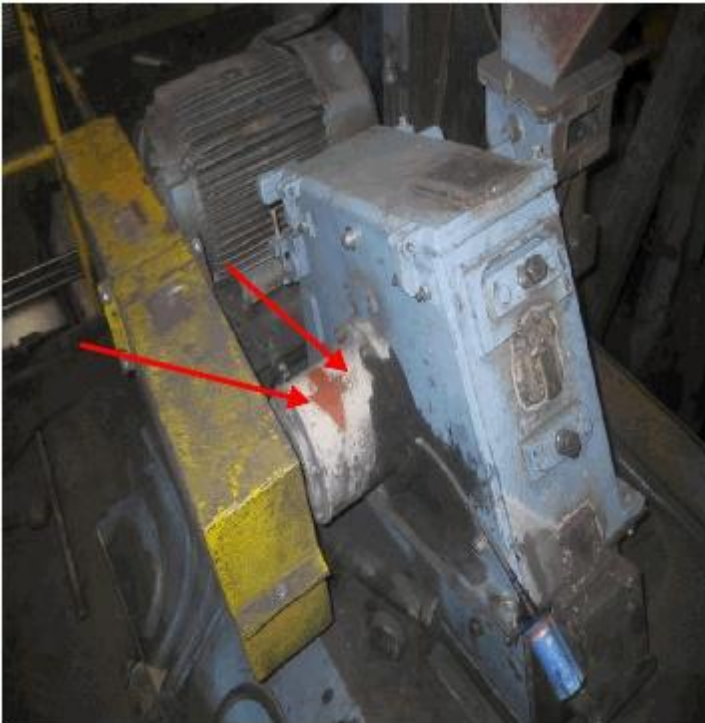
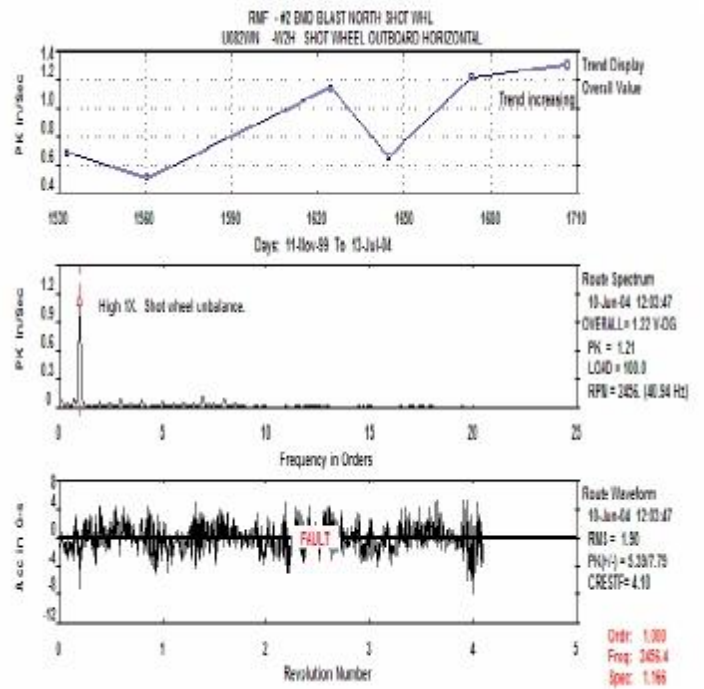
Area Main Floor
Equipment U082WN #2 BMD BLAST NORTH SHOT WHL

Title: 12-Jul-04 - Imbalance - Bearing Component

Explanation: Overall vibration level increasing. Monitor for increasing vibration.

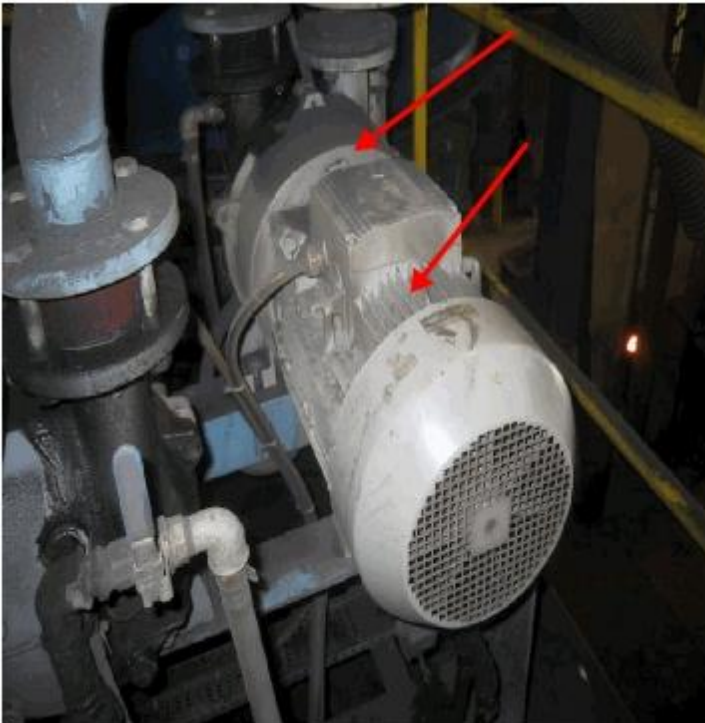
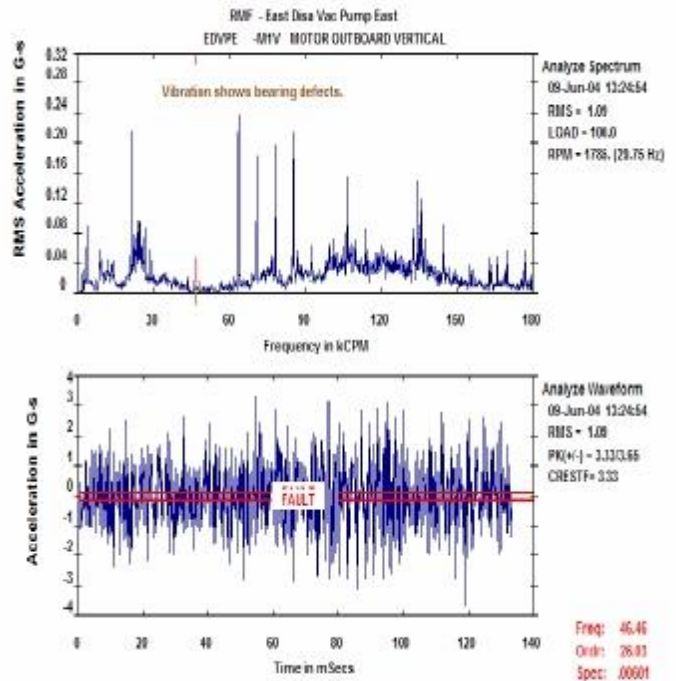
Area Main Floor
Equipment EDVPE East Disa Vac Pump East

Title: 12-Jul-04 - Antifriction bearing roller defects - Motor, AC Induction - Drive Side

Explanation: Motor bearing shows an increase in bearing defects and looseness. Monitor closely, inspect and replace/repair as needed.

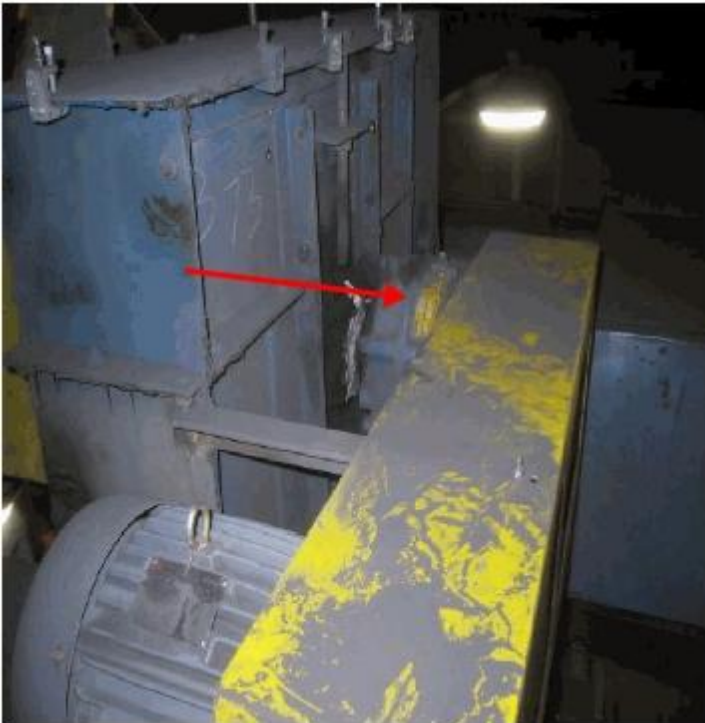
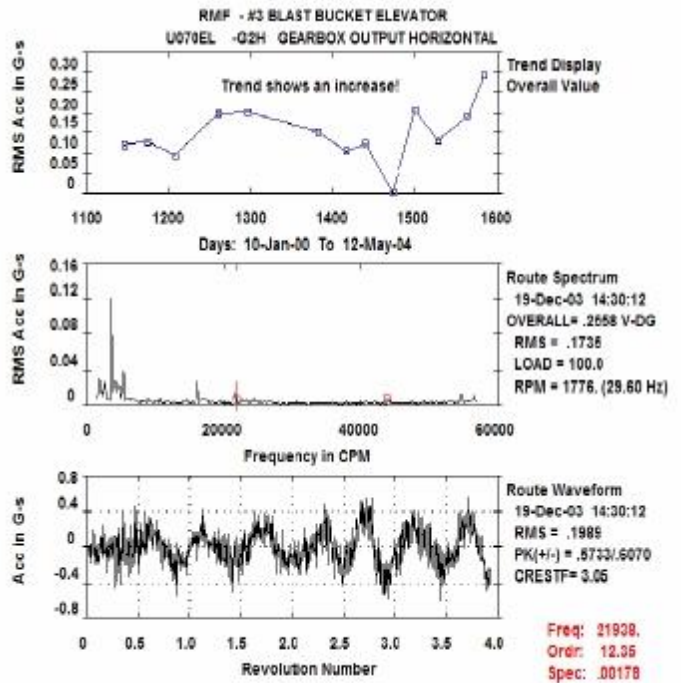
Area Main Floor
Equipment U070EL #3 BLAST BUCKET ELEVATORS

Priority 3	U070EL #3 BLAST BUCKET ELEVATOR	12-Jul-04 - Gear defects - Gear, Simple	Increased vibration levels in gearbox indicate gear wear and gear defects. Replace this gearbox within the next 30-60 days.
Priority 3	U042 EIRICH MIXER UNIT #42	12-Jul-04 - Other electrical faults - Unknown / Other - Unknown	Bad sensors detected on positions 1RW,2RW, 4RE 9RW&10RE Replace sensors.
Priority 3	U035 SAND COOLER AERATOR #35	12-Jul-04 - Antifriction bearing defect - Bearing Component	The south east aerator bearing is showing defects due to contamination. Inspect and repair as needed.
Priority 3	U036BL FLUIDBED COOLING BLOWER #36	12-Jul-04 - Antifriction bearing defect - Air Handler (Fan) - Drive	Vibration trending upwards and bearing inner race defect frequencies are showing up in the spectrum.
Priority 3	U107 DIDION RETURN SAND BELT #107	12-Jul-04 - Antifriction bearing defect - Motor, AC Induction	Vibration shows motor bearing defects, inspect motor and replace or repair as needed.

Title: 12-Jul-04 - Gear defects - Gear, Simple

Explanation: Increased vibration levels in gearbox indicate gear wear and gear defects. Monitor and inspect for shaft and gear wear. Replace/repair as needed.

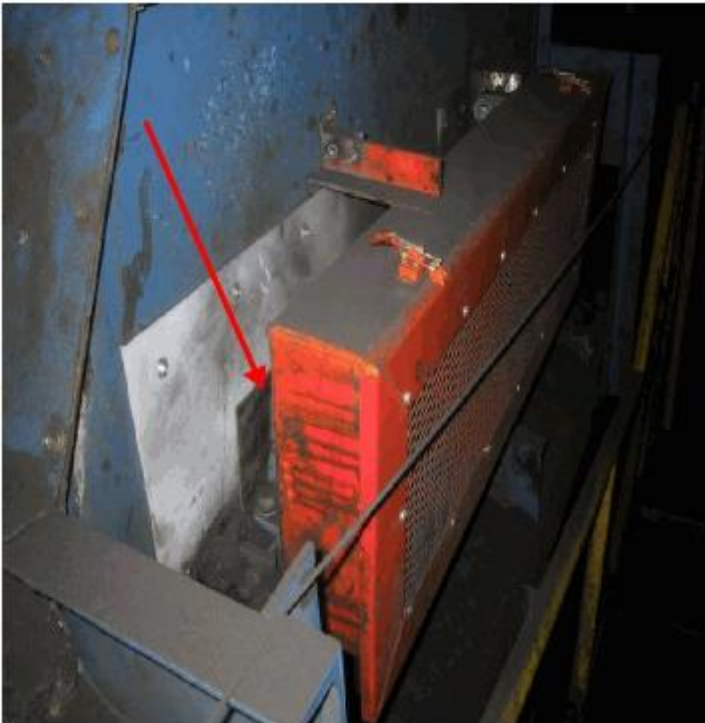
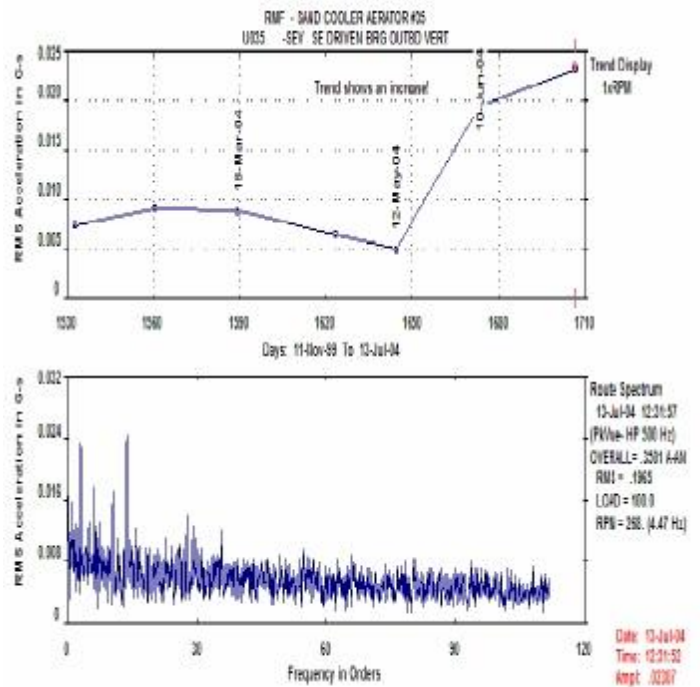
Area Main Floor
Equipment U035 SAND COOLER AERATOR #35

Title: 12-Jul-04 - Antifriction bearing defect - Bearing Component

Explanation: The south east aerator bearing is showing defects due to contamination. Inspect and repair as needed.

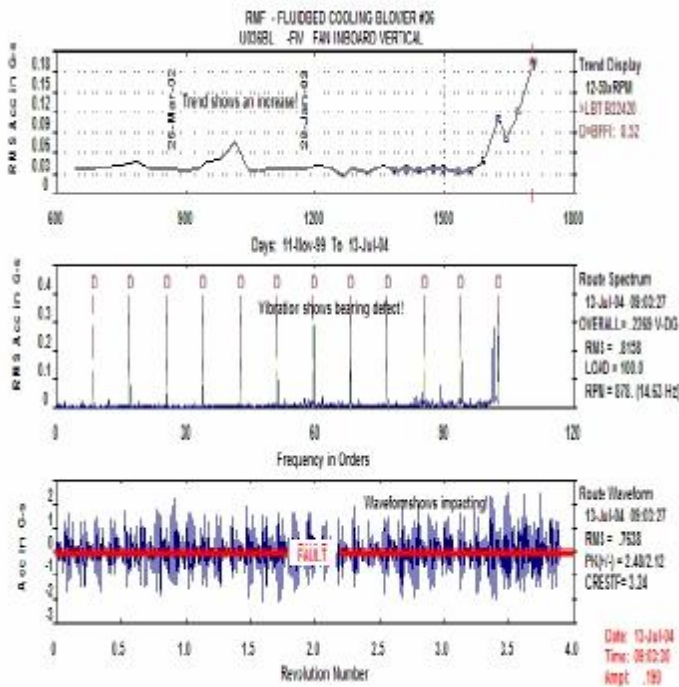
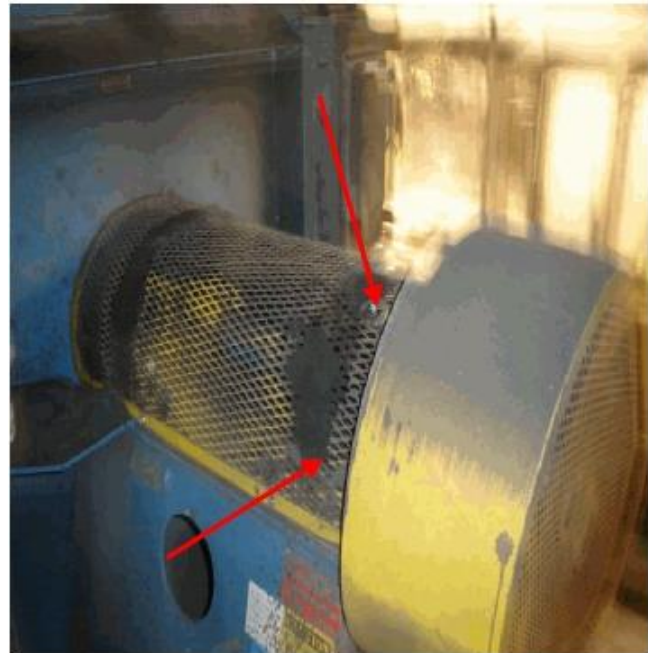
Area Main Floor
Equipment U036BL FLUIDBED COOLING BLOWER #36

Title: 12-Jul-04 - Antifriction bearing defect - Air Handler (Fan) - Drive Side

Explanation: Vibration trending upwards and bearing inner race defect frequencies are showing up in the spectrum.

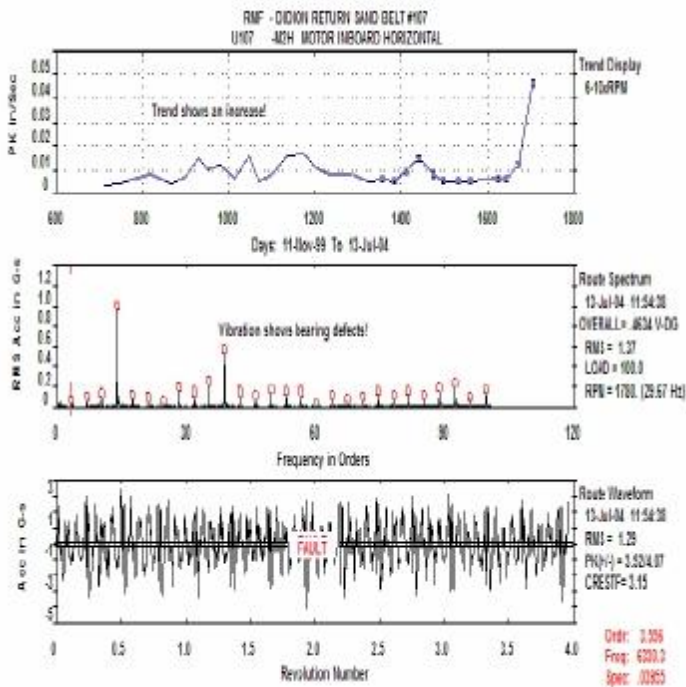
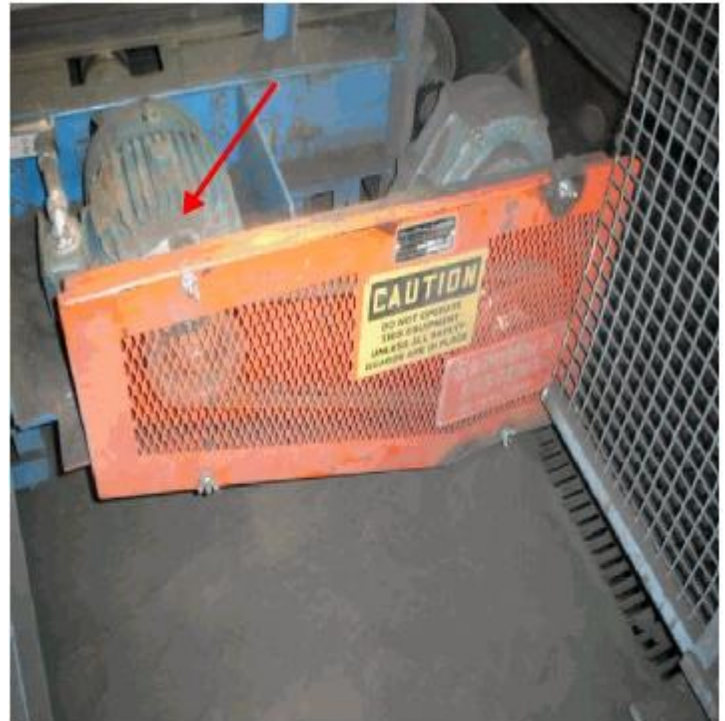
Area Main Floor
Equipment U107 DIDION RETURN SAND BELT #107

Title: 12-Jul-04 - Antifriction bearing defect - Motor, AC Induction

Explanation: Vibration shows motor bearing defects, inspect motor and replace or repair as needed.

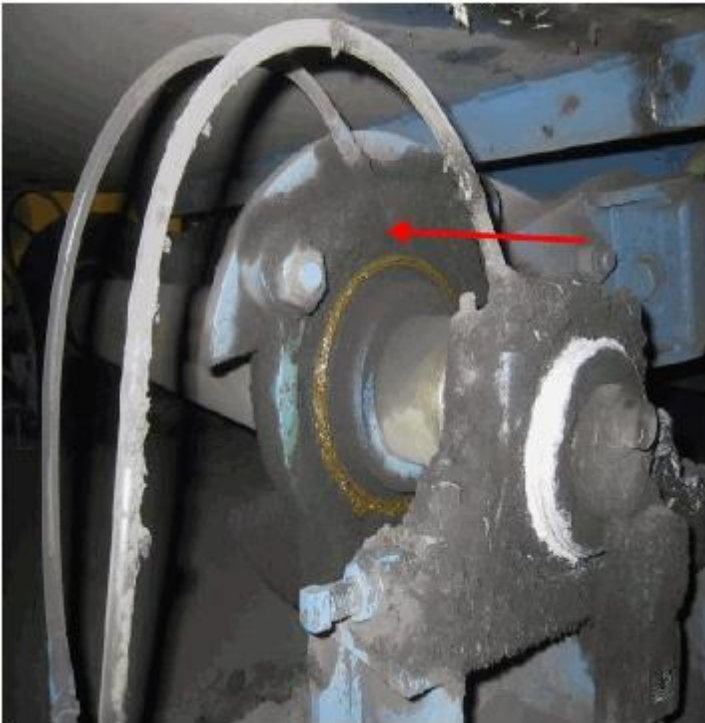
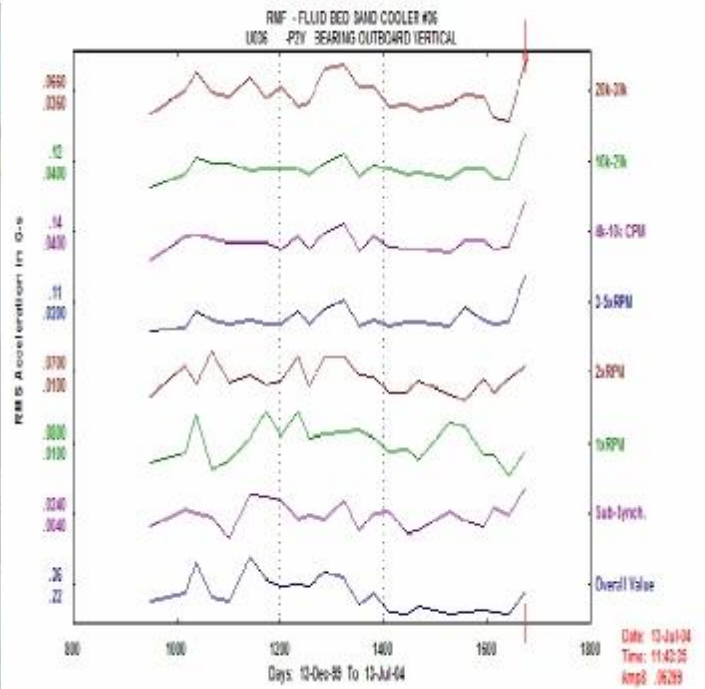
Area Main Floor
Equipment U036 FLUID BED SAND COOLER #36

Title: 12-Jul-04 - Antifriction bearing defect - Bearing Component - Outboard

Explanation: The outboard flange bearing vibration data shows minor defect frequencies. Monitor this condition.

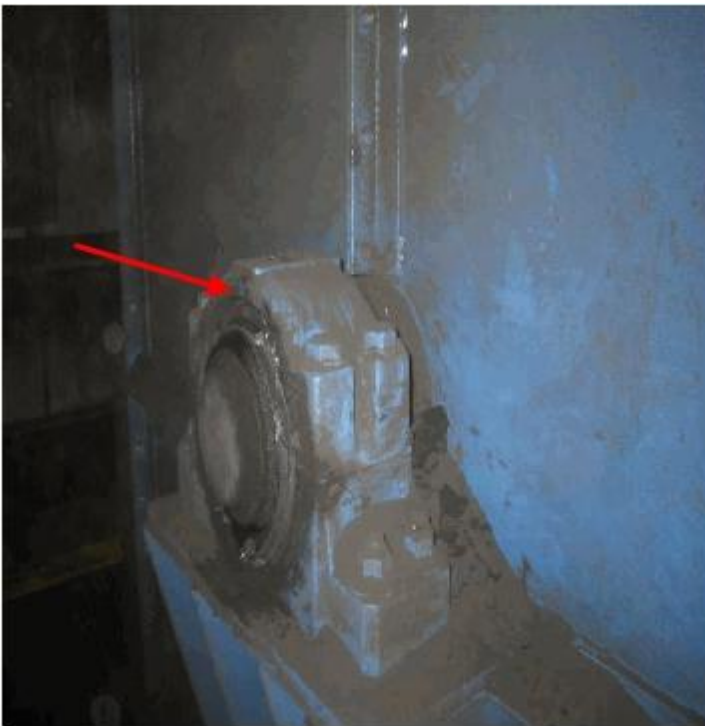
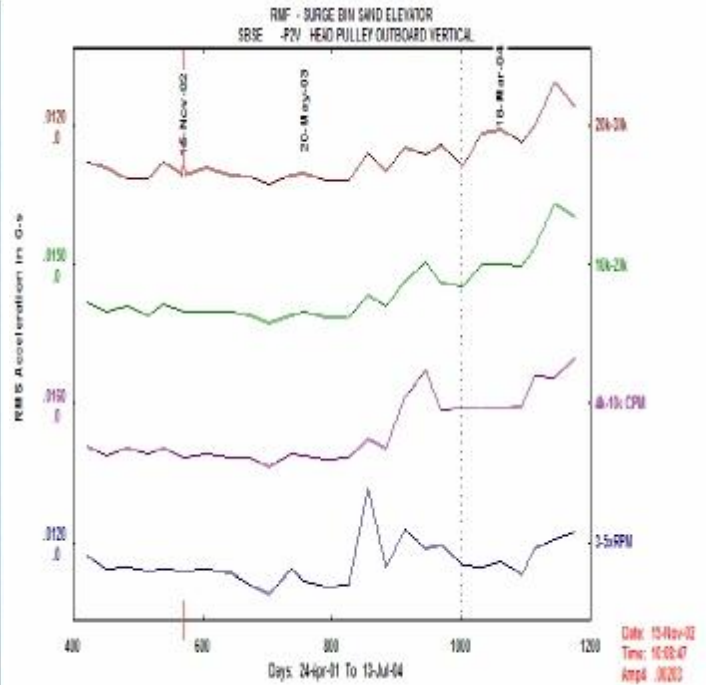
Area Main Floor
Equipment SBSE SURGE BIN SAND ELEVATOR

Title: 12-Jul-04 - Antifriction bearing defect - Bearing Component

Explanation: The Surge Bin Elevator Head Pulley Bearings are showing an increase of vibration due to contamination. The source of contamination, which was due to positive pressure in the elevator and surge bin, has been corrected. However the bearing seals have been compromised and the resulting bearing contamination has caused some early bearing defects. Lubricate bearings frequently and monitor this condition.

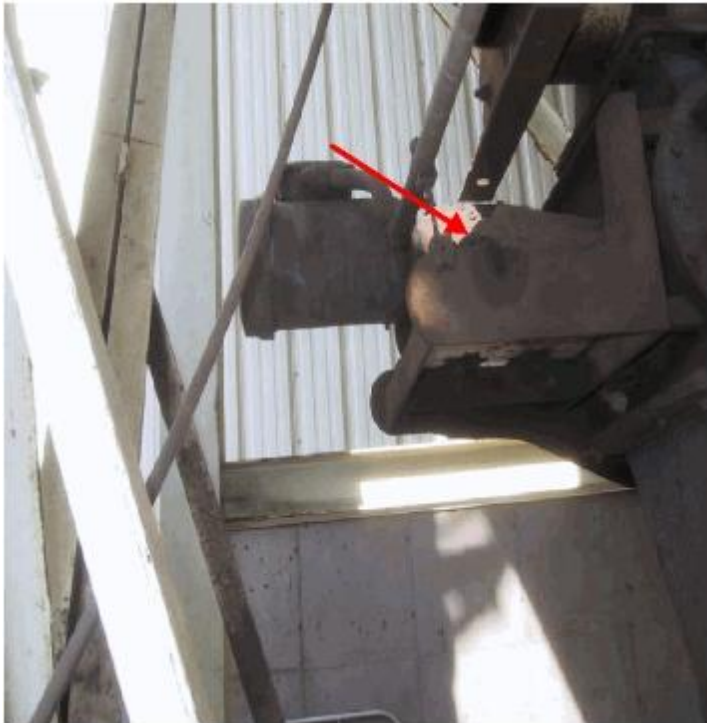
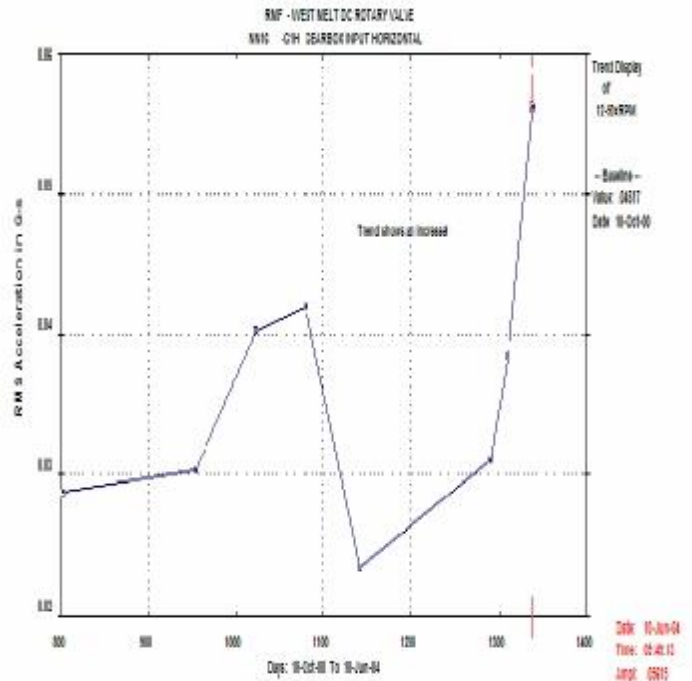
Area Main Floor
Equipment NN16 WEST MELT DC ROTARY VALVE

Increased vibration in the gearbox indicates early gear defects. Monitor this machine closely.

Title: 12-Jul-04 - Gear defects - Gear, Simple

Explanation: Increased vibration in the gearbox indicates early gear defects.
Monitor this machine closely.

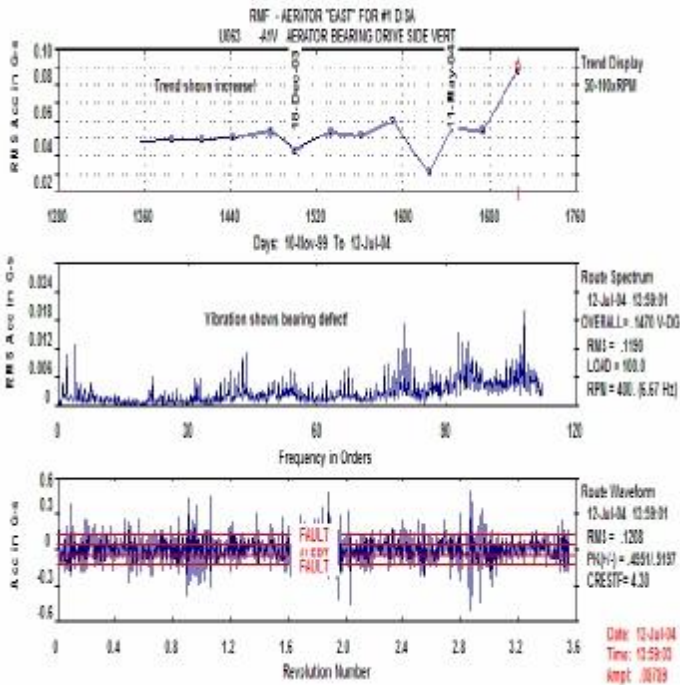
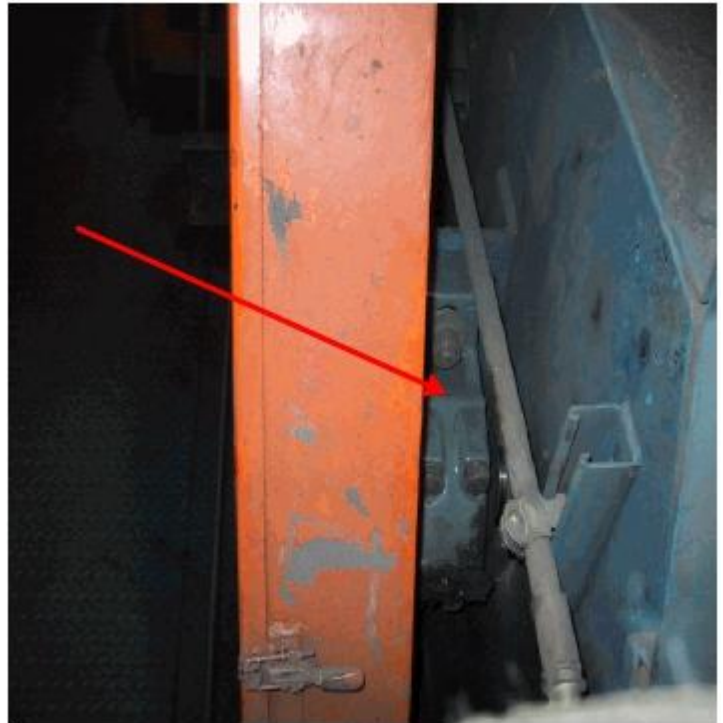
Area Main Floor
Equipment U063 AERATOR "EAST" FOR #1 DISA

Vibration spectrum shows early stage bearing defects, due to contamination. Monitor this condition.

Title: 12-Jul-04 - Antifriction bearing defect - Bearing Component

Explanation: Vibration spectrum shows early stage bearing defects, due to contamination. Monitor this condition.

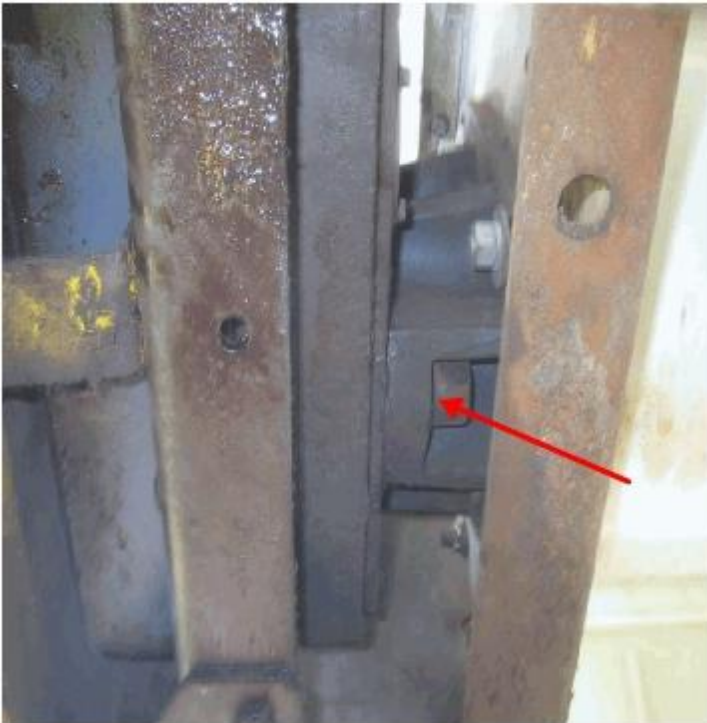
Area Main Floor
Equipment NN14 WEST MELT DC SCREW CONV.

Gearbox mounting bolt is loose. Gearbox is oscillating. Bolts should be tightened at next opportunity to avoid damage.

Title: 12-Jul-04 - Hold down bolts loose - Gear, Simple

Explanation: Gearbox mounting bolt is loose. Gearbox is oscillating. Bolts should be tightened at next opportunity to avoid damage.

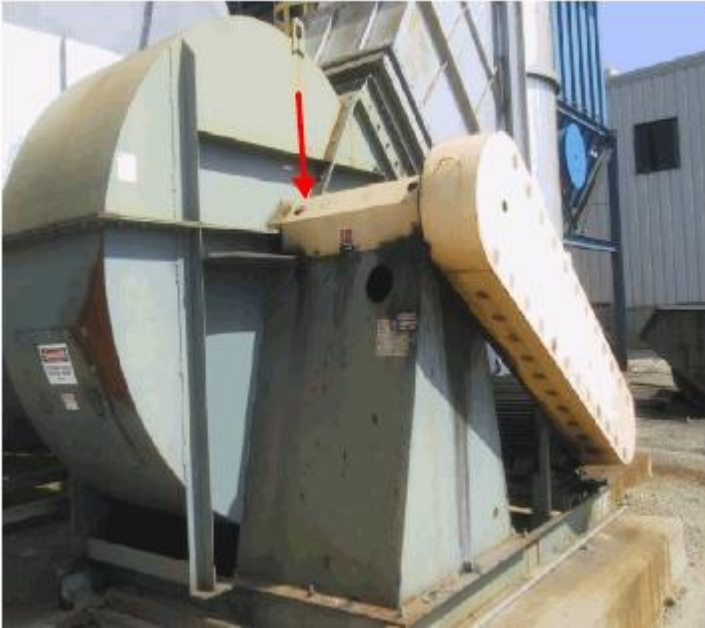
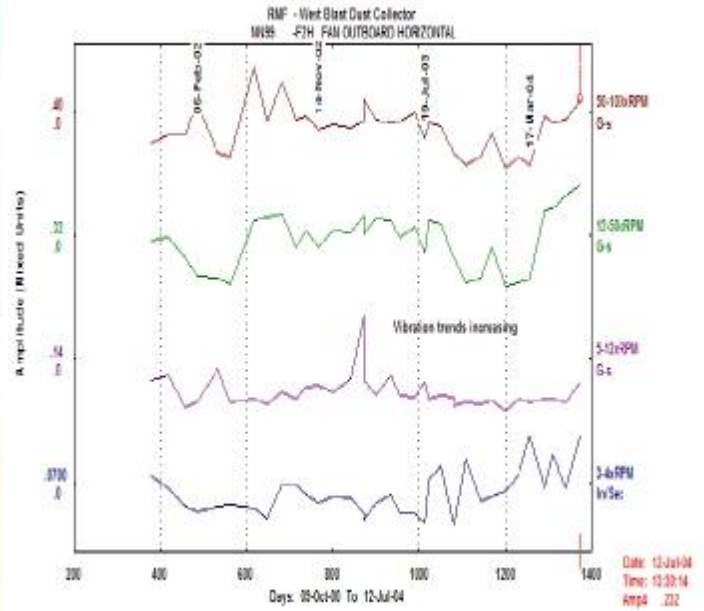
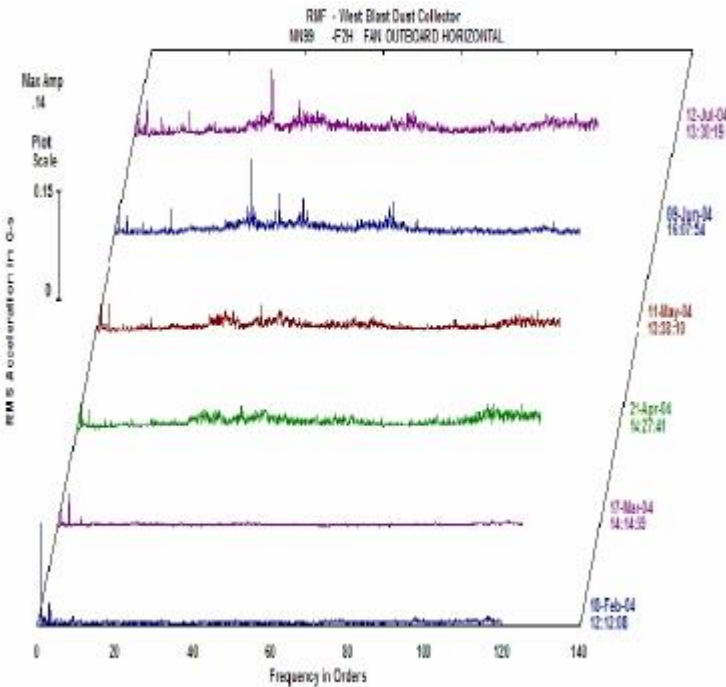
Area Main Floor
Equipment NN99 West Blast Dust Collector

Increase of vibration on fan bearings indicates early wear, monitor this condition. Corrective action not required as of this survey.

Title: 12-Jul-04 - Antifriction bearing defect - Air Handler (Fan)

Explanation: Increase of vibration on fan bearings indicates early wear, monitor this condition. Corrective action not required as of this survey.
